Manhole Inspection Summary

Manhole # S17KK_010MH

Insp Date: **2/27/08 8:46 AM**

Location Address: **1730 WARWICK AVE**

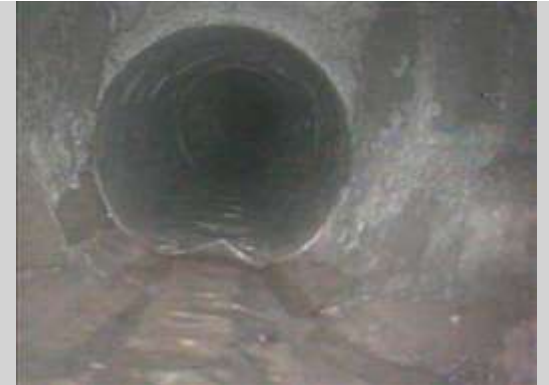
12 O'Clock Outflow

8 in. Circular Gravity Sewer
Pipe Out @ 12 O'Clock

Pipe Material: **Clay** ☐ Pipe Lined

Invert Depth: **15.65** (ft.) Flow Characteristics: **Slow**

Deposits: ☒ None ☐ Mud ☐ Sludge ☐ Debris ☐ Grease

Infiltration: **None** Pipe Seal Cond: **Sound**

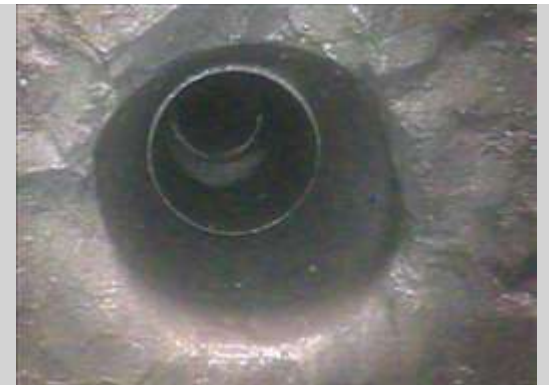
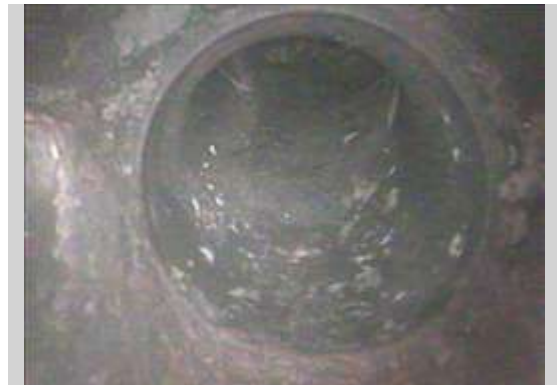
3 O'Clock Inflow

8 in. Circular Gravity Sewer
Pipe In @ 3 O'Clock

Drop In @ 3 O'Clock

Pipe Material: **Clay** ☐ Pipe Lined

Invert Depth: **5.30** (ft.) Flow Characteristics: **Slow**

Infiltration: **None** Pipe Seal Cond: **Sound**

Drop: **Outside Direct**

Inv Depth: **15.45** (ft.)

Drop Condition: **Open**

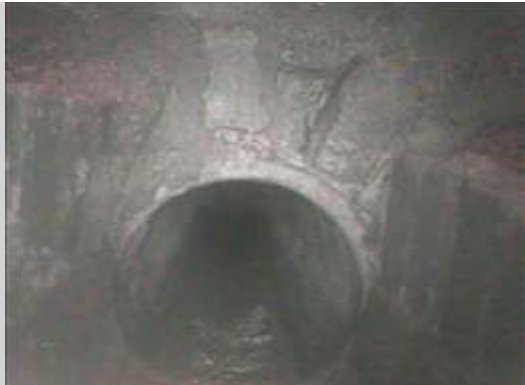
6 O'Clock Inflow

8 in. Circular Gravity Sewer

Pipe In @ 6 O'Clock

Pipe Material: **Clay** ☐ Pipe Lined

Invert Depth: **15.62** (ft.) Flow Characteristics: **Slow**

Infiltration: **None** Pipe Seal Cond: **Sound**

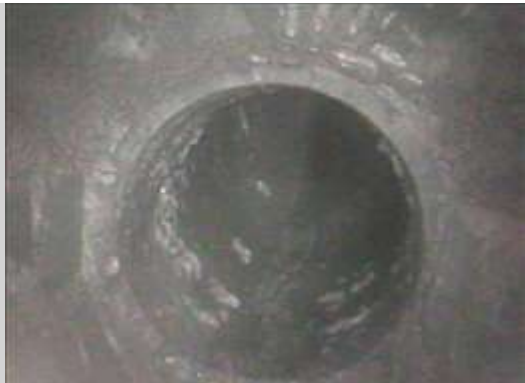
9 O'Clock Inflow

8 in. Circular Gravity Sewer

Pipe In @ 9 O'Clock

Pipe Material: **Clay** ☐ Pipe Lined

Invert Depth: **15.45** (ft.) Flow Characteristics: **Fast**

Infiltration: **None** Pipe Seal Cond: **Sound**
